Introduction

The Cummings Life Science Building is an eleven story 162,000 square foot concrete/masonry laboratory and research building. Located at 920 East 58th Street, Chicago, Illinois, this building houses numerous researchers of genetics, microbiology, and cell biology for the Biological Sciences Department for the University of Chicago. In 1999, the University set out to substantially renovate much of this 32 year old building to a modern, flexible research facility. To date, nine phases of work have been completed, entirely renovating approximately 100,000 gross square feet of space on floors 3, 5, 6, 7, 8, 9, a portion of 10, and a portion of the basement. In order to support these renovations, significant upgrades to the buildings infrastructure were required. These infrastructure upgrades include converting the building's main air handling systems to variable air volume, a 215,000 cfm laboratory exhaust system, new radioisotope exhaust systems, a high pressure exhaust riser serving a Biological Safety Level 3 (BSL3) lab, a process chilled water system, new electrical distribution, new reverse osmosis system, replacement of domestic water systems, and integration of a st

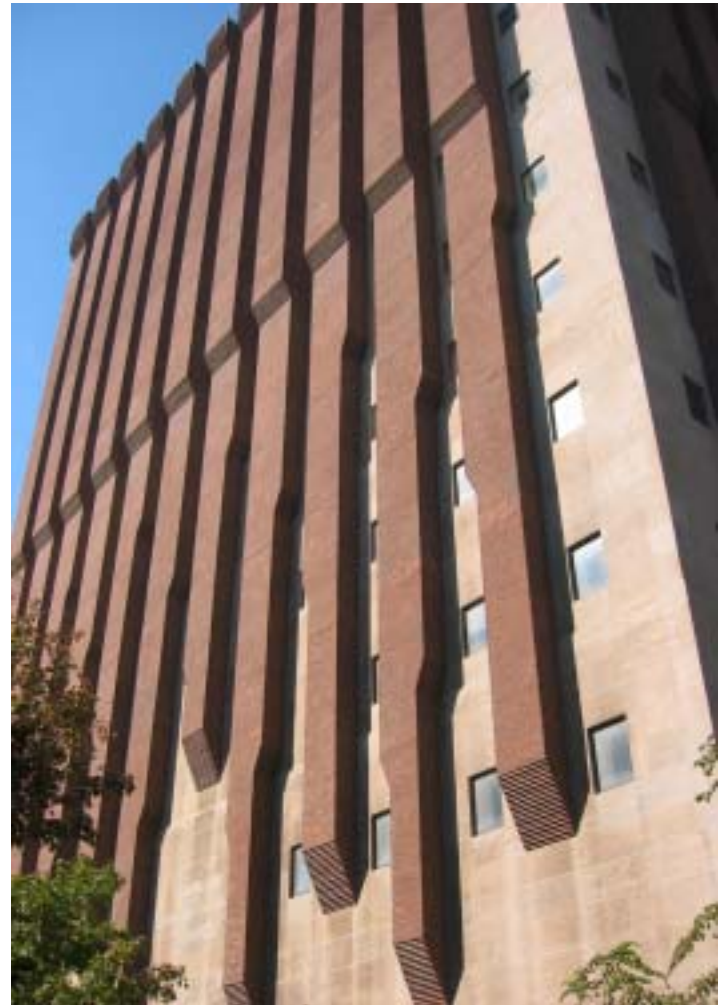
Figure 1-The distinctive concrete columns on the exterior of the building, which house the original lab exhaust riser, presented many challenges to the renovation of the exhaust system.

Making matters worse, the building's unique masonry structure had imposed a significant impact on the design of the HVAC systems for the building. The exterior of the building includes 40 masonry and concrete shafts. Nearly 200 individual 10"x14" laboratory exhaust risers were routed up these shafts, served by 56 exhaust fans on the 11th /12th floor roofs. Each fan served a small section of the building on four or five floors. As expected, a building with so many fan systems had become difficult to maintain. Many of the 56 individual exhaust fans required significant maintenance, and some of the fans were inoperable, leaving areas of the building without any means of exhaust.

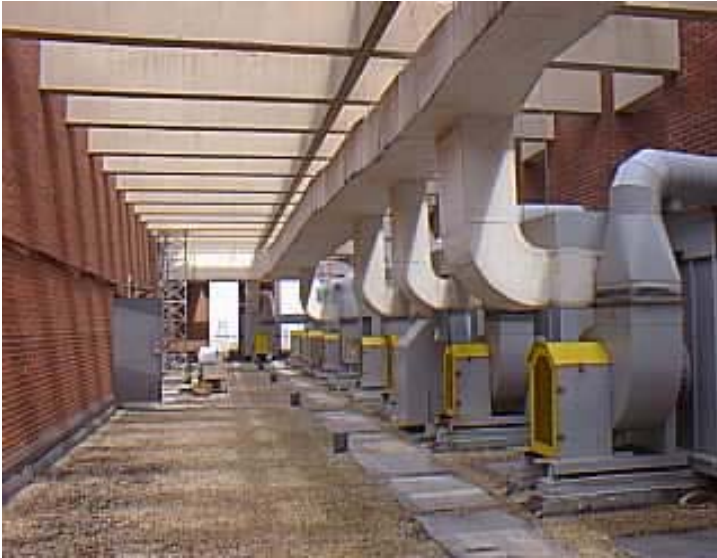
Figure 2 - Originally, the building was served by 56 lab exhaust fans. Each fan served four or five separate floors.

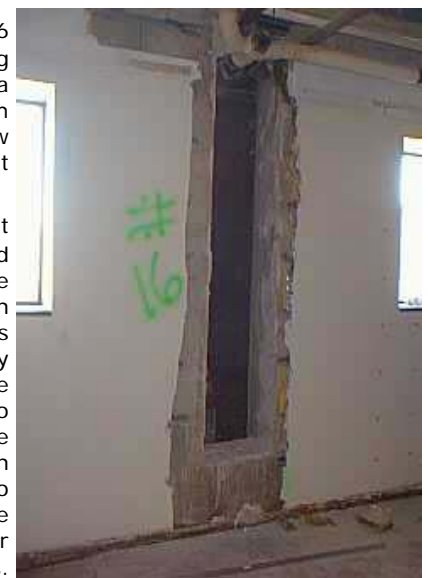
Figure 3-A 16" access to each exterior duct shaft was all that was available, limiting options on

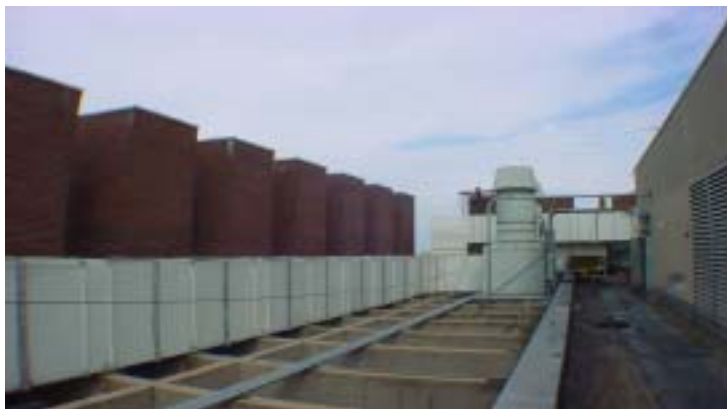
Figure 4-New lab exhaust fans were provided at each quadrant of the building and manifolded together by a

1. A total of four laboratory exhaust fan systems would be installed on the roof of the building. Each fan system would include three fans (or two fans with a space for a future fan- See Figure 4). The fan systems would be located at the four quadrants of the building at the roof level. This permitted their high velocity nozzles to discharge air from the laboratories and fume hoods at the highest point of the building, far away from the outside air intakes for this building as well as all of the surrounding buildings. A 60"x60" coated duct manifold was installed looping the entire roof area near the perimeter. Each of the four lab exhaust fans were connected into this common manifold. All of this work was installed prior to the start of any renovation on any floor.

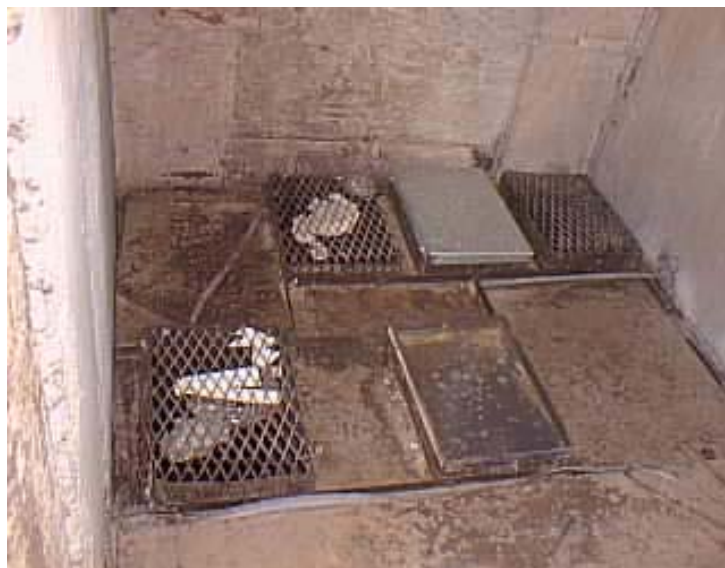
Figure 5-Inside the top of each exterior shaft, 4-6 lab exhaust ducts originally terminated in a plenum. Each plenum was served by one or two of the 56 original exhaust fans. A venturi style air valve was installed on each duct during the renovation, and connected to the new medium pressure lab exhaust system.

2. Once this work had been accomplished, each shaft underwent a renovation. This renovation intercepted each of the four to six exhaust ducts at the top of each shaft (See Figure 5), and installed a variable air volume venturi style air valve on each branch duct. The shafts at the roof line included an interior access space approximately 5'x5', allowing the valves to set in a vertical position on top of the exhaust riser it served, in a space protected from the exterior elements. Each air valve was then extended to the new 60"x60" exhaust manifold.

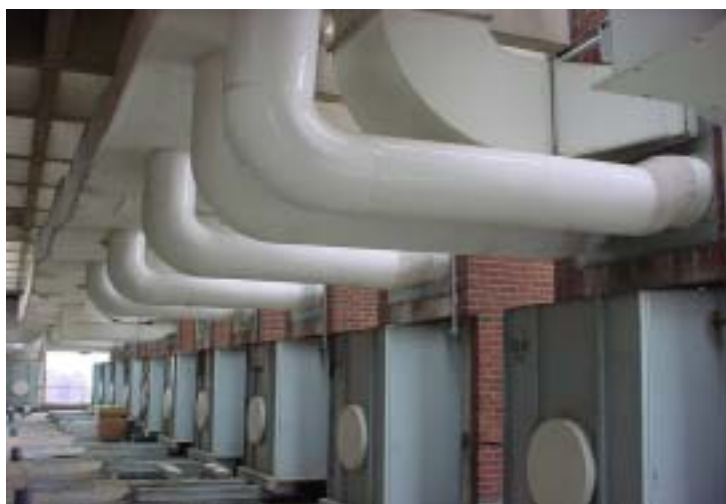
Figure 6- Photo after the 56 exhaust fans were demolished, with the building now served by new lab exhaust fans. Round white insulated ducts are return ducts serving certain duct risers within

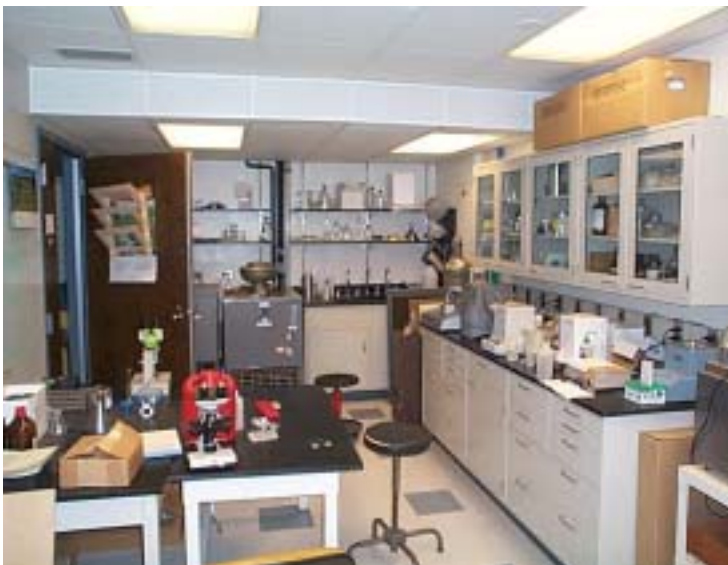
Figure 7: Typical lab space before renovation. Poor lighting and comfort control as well as low ceiling heights contributed to a poor working environment.

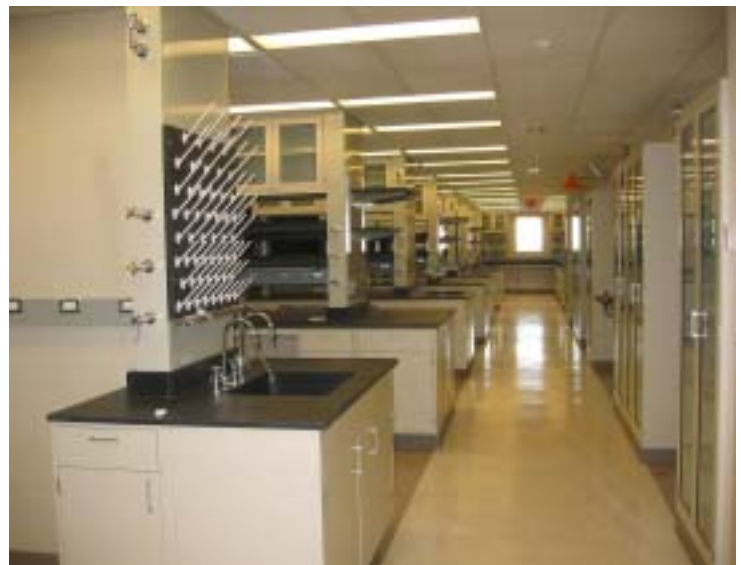
Figure 8: Typical lab space after renovation. Ceiling heights are higher, lighting and thermal comfort has been dramatically increased, while also providing a much safer and energy efficient building.

environment, where good room pressure control is a must. Because of the extensive field survey which had been conducted, ductwork, piping, cable tray, conduit feeders and the like were highly coordinated during the design phase, resulting in much higher ceilings in nearly all of the areas. Previously, ceiling heights were a maximum of 8'-0", with some areas as low as 7'-6". New ceiling heights, even after including increased air flow rates to the floor, are 8'-6" over nearly 80% of the floor.
